NIST NCSTAR 1A

**Federal Building and Fire Safety Investigation of the
World Trade Center Disaster**

Final Report on the Collapse of World Trade Center Building 7

August, 2008

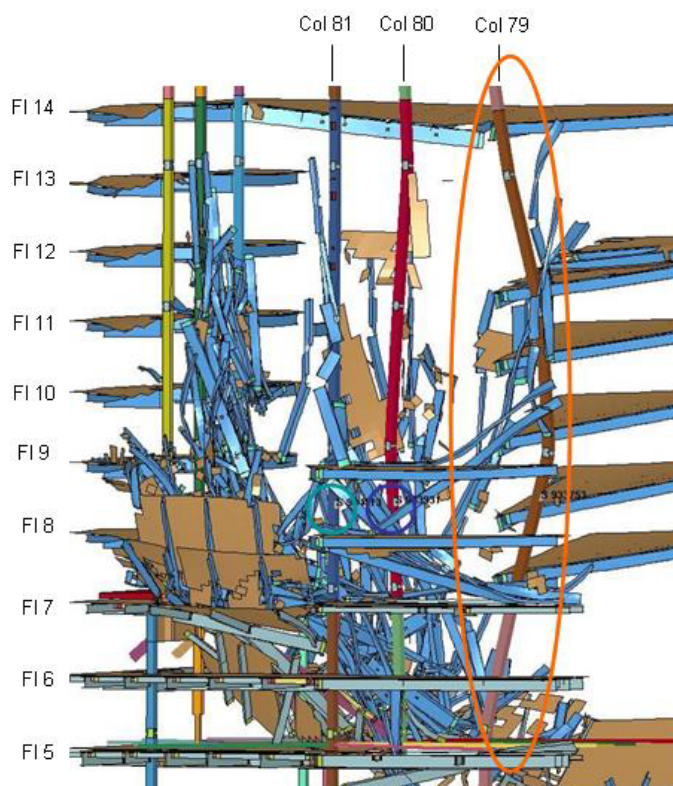
Fire-induced thermal expansion of the floor system surrounding Column 79 led to the collapse of Floor 13, which triggered a cascade of floor failures. In this case, the floor beams on the east side of the building expanded enough that they pushed the girder connecting Columns 79 and 44 to the west on the 13th floor. (See Figure 1–5 for column numbering and the locations of girders and beams.) This movement was enough for the girder to lose its connection to Column 79.

The displaced girder and other local fire-induced damage caused Floor 13 to collapse, beginning a cascade of floor failures down to the 5th floor (which, as noted in Section 1.2.3, was much thicker and stronger). Many of these floors had already been at least partially weakened by the fires in the vicinity of Column 79. This left Column 79 with insufficient lateral support in the east-west direction. The column buckled eastward, becoming the initial local failure for collapse initiation.

Figure 2–2. Eastward buckling of Column 79, viewed from the southeast.

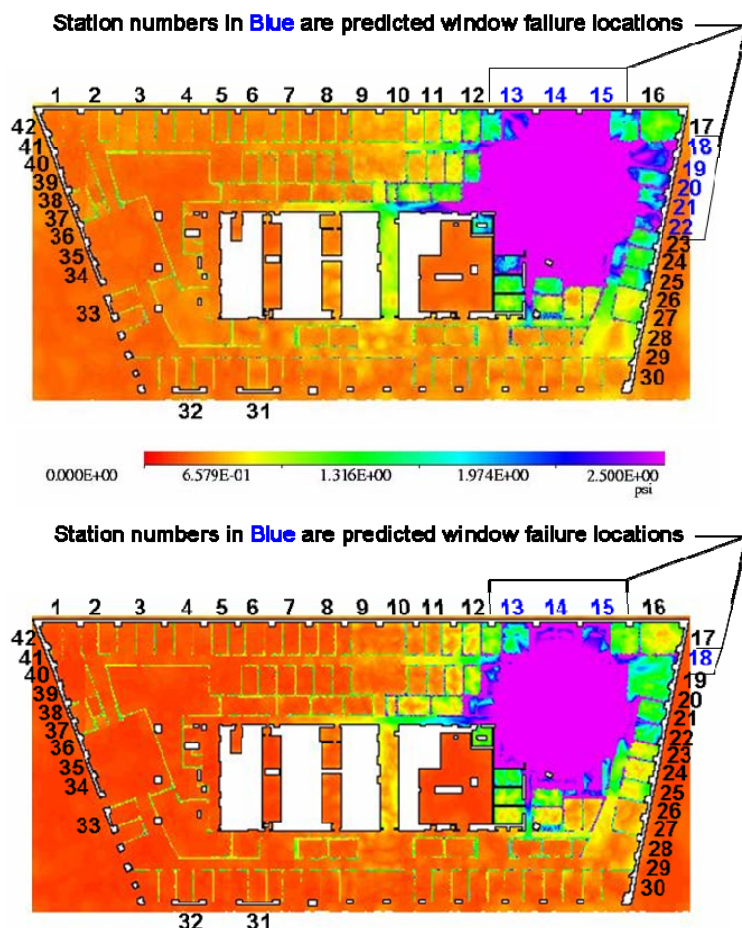
Figure 3–1 shows the results for the two shaped charges applied to Column 79 on a tenant floor that was highly partitioned, such as Floor 12. Nearly all the windows on the northeast section of the blast floor

would have been broken, even by the smaller charge. Simulations for open landscaped floors led to more extensive window breakage.

Figure 3–1. Peak overpressure and broken window locations.

Top: 9 lb shaped charge; bottom: 2 lb charge.

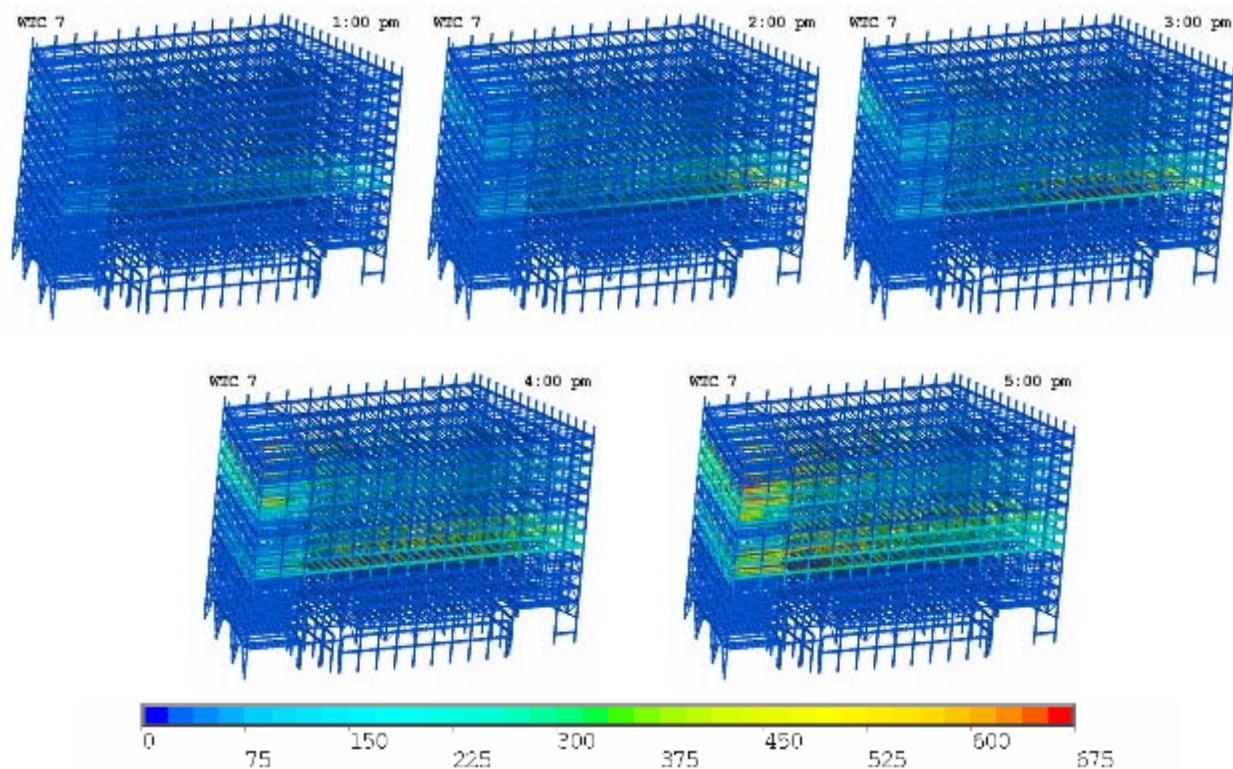
Figure 3–7 shows the calculated heating of the structural steel on the lower 16 floors of WTC 7 for the Case B temperatures from the fire simulation. The floor slabs have been removed from the figure for clarity. Figure 3–8 is a typical rendition of the calculated heating of the top of a floor slab as a result of the Case B fire.

Figure 3–7. View from the northeast of the computed heating of the lower 16 floors of WTC 7 at five different instants in time.

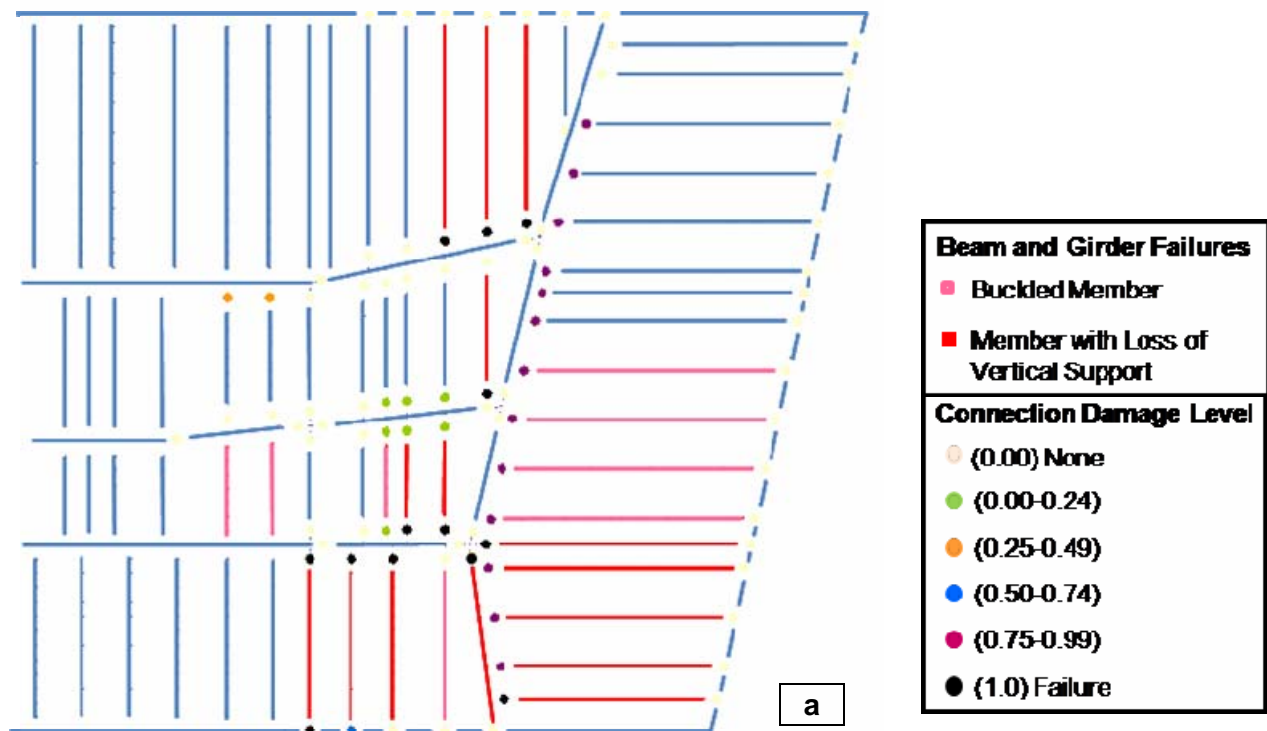
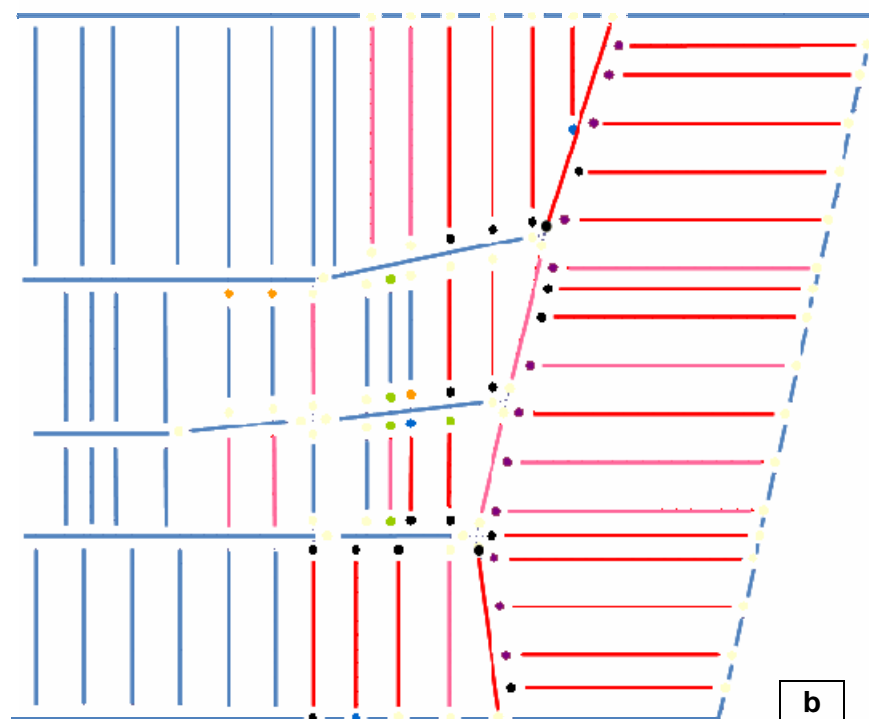
Figure 3-9 shows an example of the extent of structural damage from the fires, in this case for the 13th floor. At both 3.5 h and 4.0 h, connections, floor beams, and girders were damaged or had failed at steel temperatures that were approximately 400 °C or less, primarily due to the effects of thermal expansion. After 4.0 h of heating, there was substantially more damage and failures in the WTC 7 structural system than at 3.5 h of heating.

Figure 3–9. Damage state of connections in Floor 13 for Case B temperatures.

a: at 3.5 h; b: at 4.0 h

The second LS-DYNA analysis (lesser degree of fire-induced damage) did not lead to a collapse-initiating event, despite the extensive damage shown in Figure 3-9a.

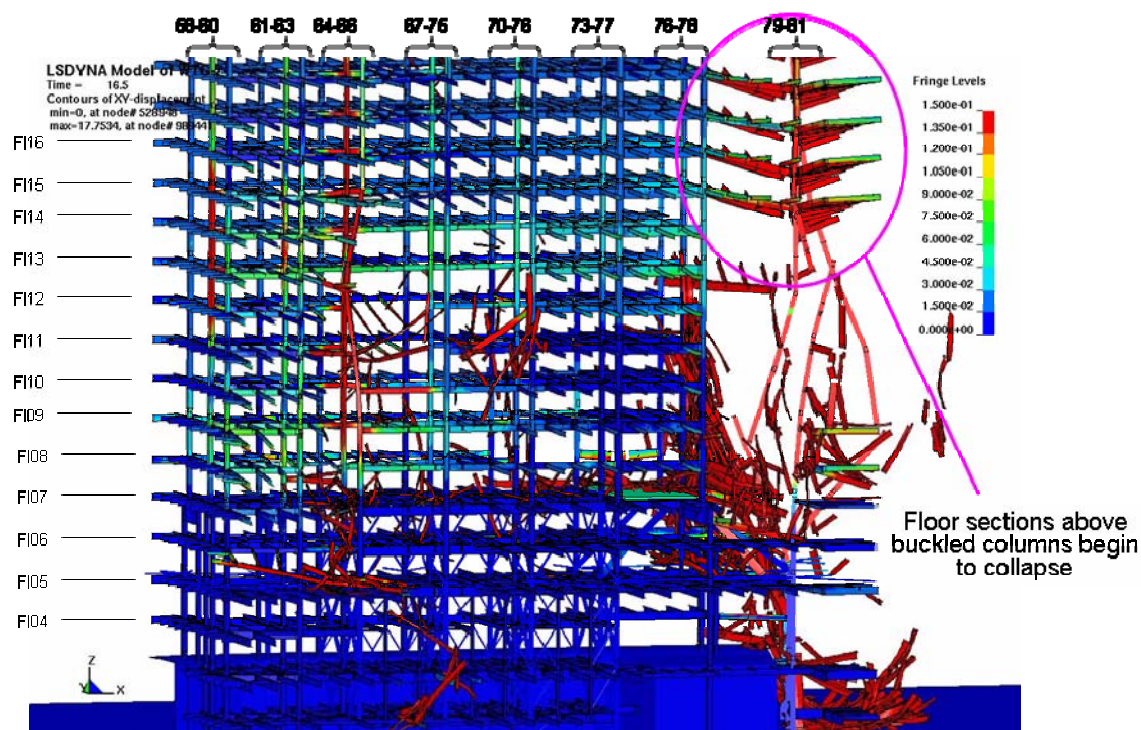
Figure 3–10 shows the beginning of upper floor failures on the east side of the building at 0.5 s, following the buckling of Columns 79, 80, and 81. The east penthouse, which was supported by these three columns, had just begun to descend. About 2 s later, as shown in Figure 3–11, the collapse of all the east sections of all the floors had occurred, the upper floors had moved southward, Truss 2 had been damaged, and the westward progression of the building failure was underway. Figure 3–12 and Figure 3–13, only 2 s apart, indicate the speed with which the westward column failures proceeded between Floors 7 and 14.

Figure 3-10. Vertical progression of failures on the east side of the building at 0.5 s following the initiation of the collapse.

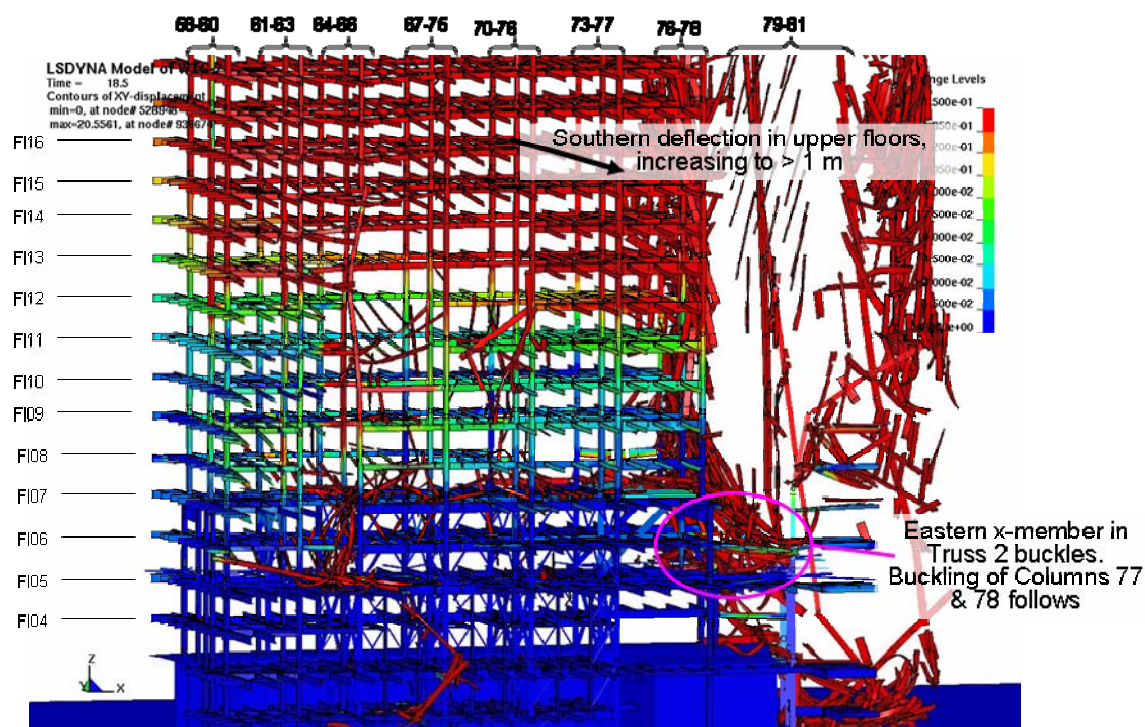
Figure 3-11. Failure of Columns 77 and 78 due to failure of Truss 2 fails from debris impact at 2.5 s following the initiation of the collapse.

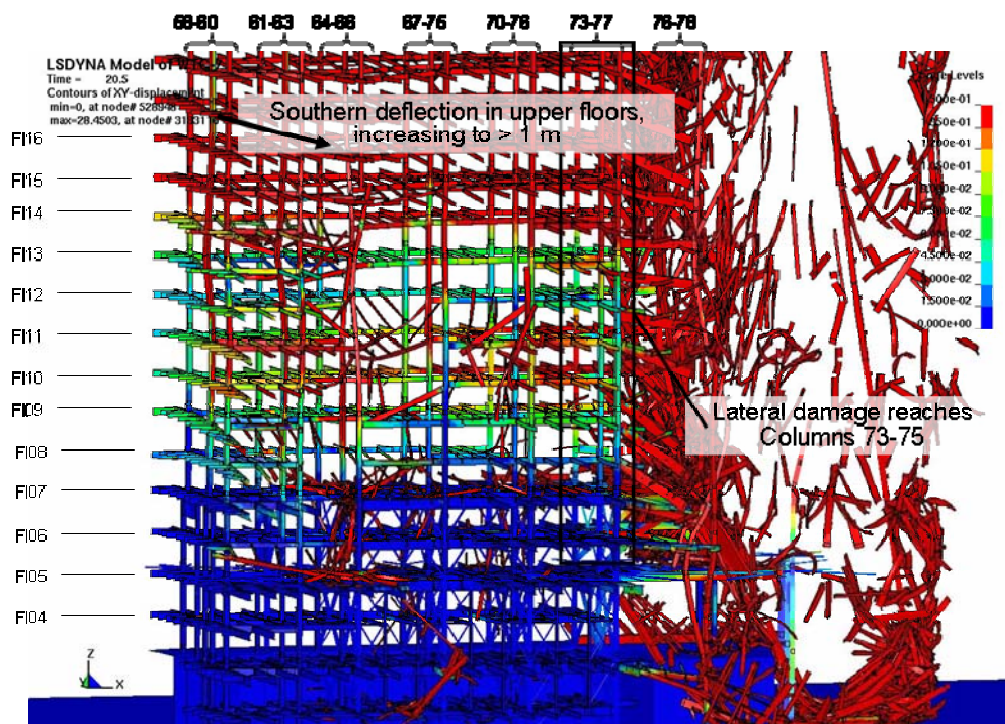
Figure 3-12. Failure of Columns 73 to 75 from the load redistribution and debris impact at 4.5 s following the initiation of the collapse.

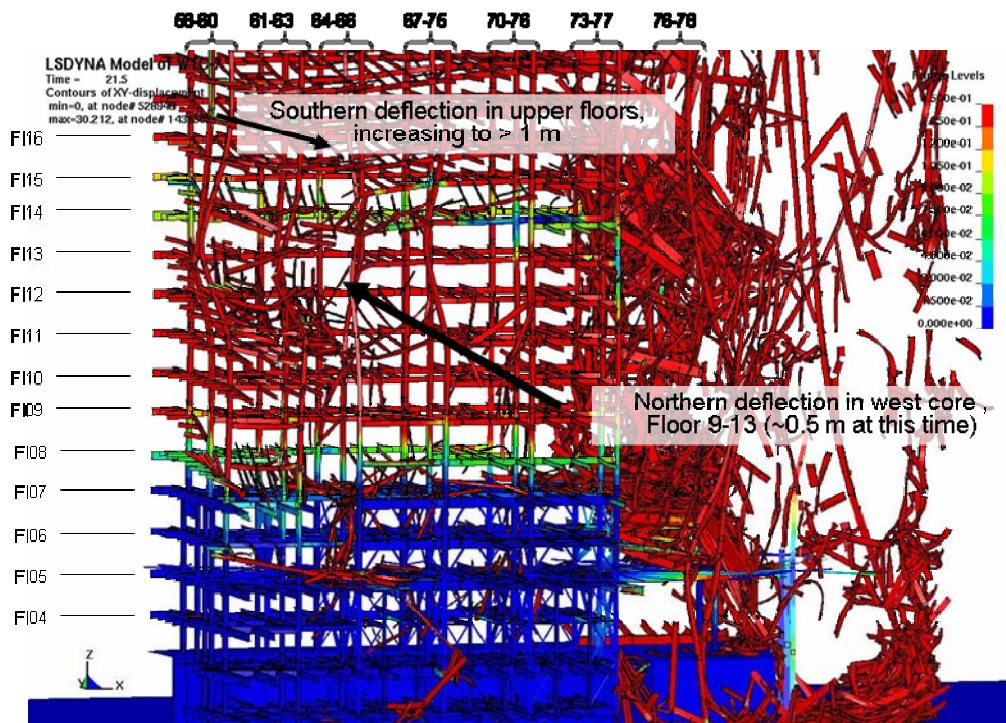
Figure 3-13. Buckling of all interior columns at 6.5 s following the initiation of the collapse.

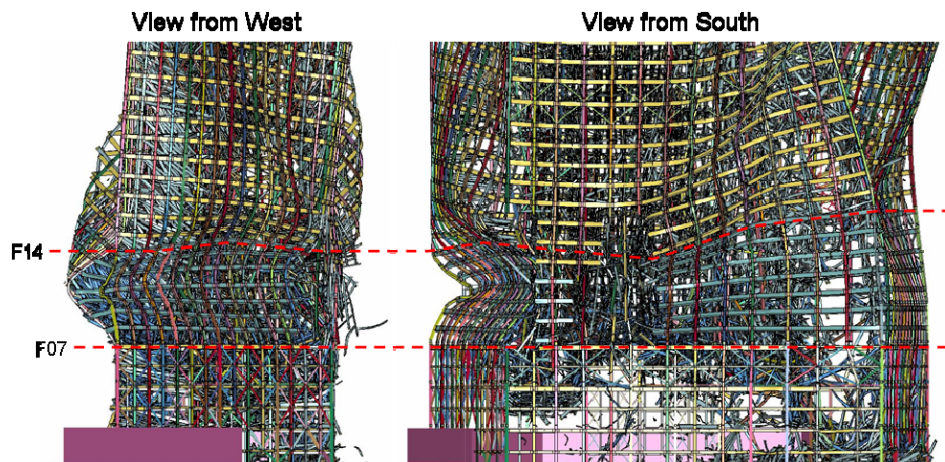
In Figure 3-14, the total collapse of the building is underway. The two views cover the lower half of the building. The purple area at the bottom is the Con Edison substation. With no fires on the west side of Floors 10 through 14, the intact floor framing pulled the exterior columns inward as the interior columns fell downward. Loads from the buckled interior columns were redistributed to the exterior columns, which, in turn, buckled the exterior columns between Floors 7 and 14 within approximately 2 s. At that point, the entire building above the buckled-column region moved downward as a single unit, resulting in the global collapse of WTC 7.

Figure 3-14. Buckling of the lower exterior columns within 1 s of Figure 3-13.
